River St. Substation Failure
Fitchburg Gas & Electric Company
June 25, 2001

Preliminary Investigation Summary
River Street Substation Summary

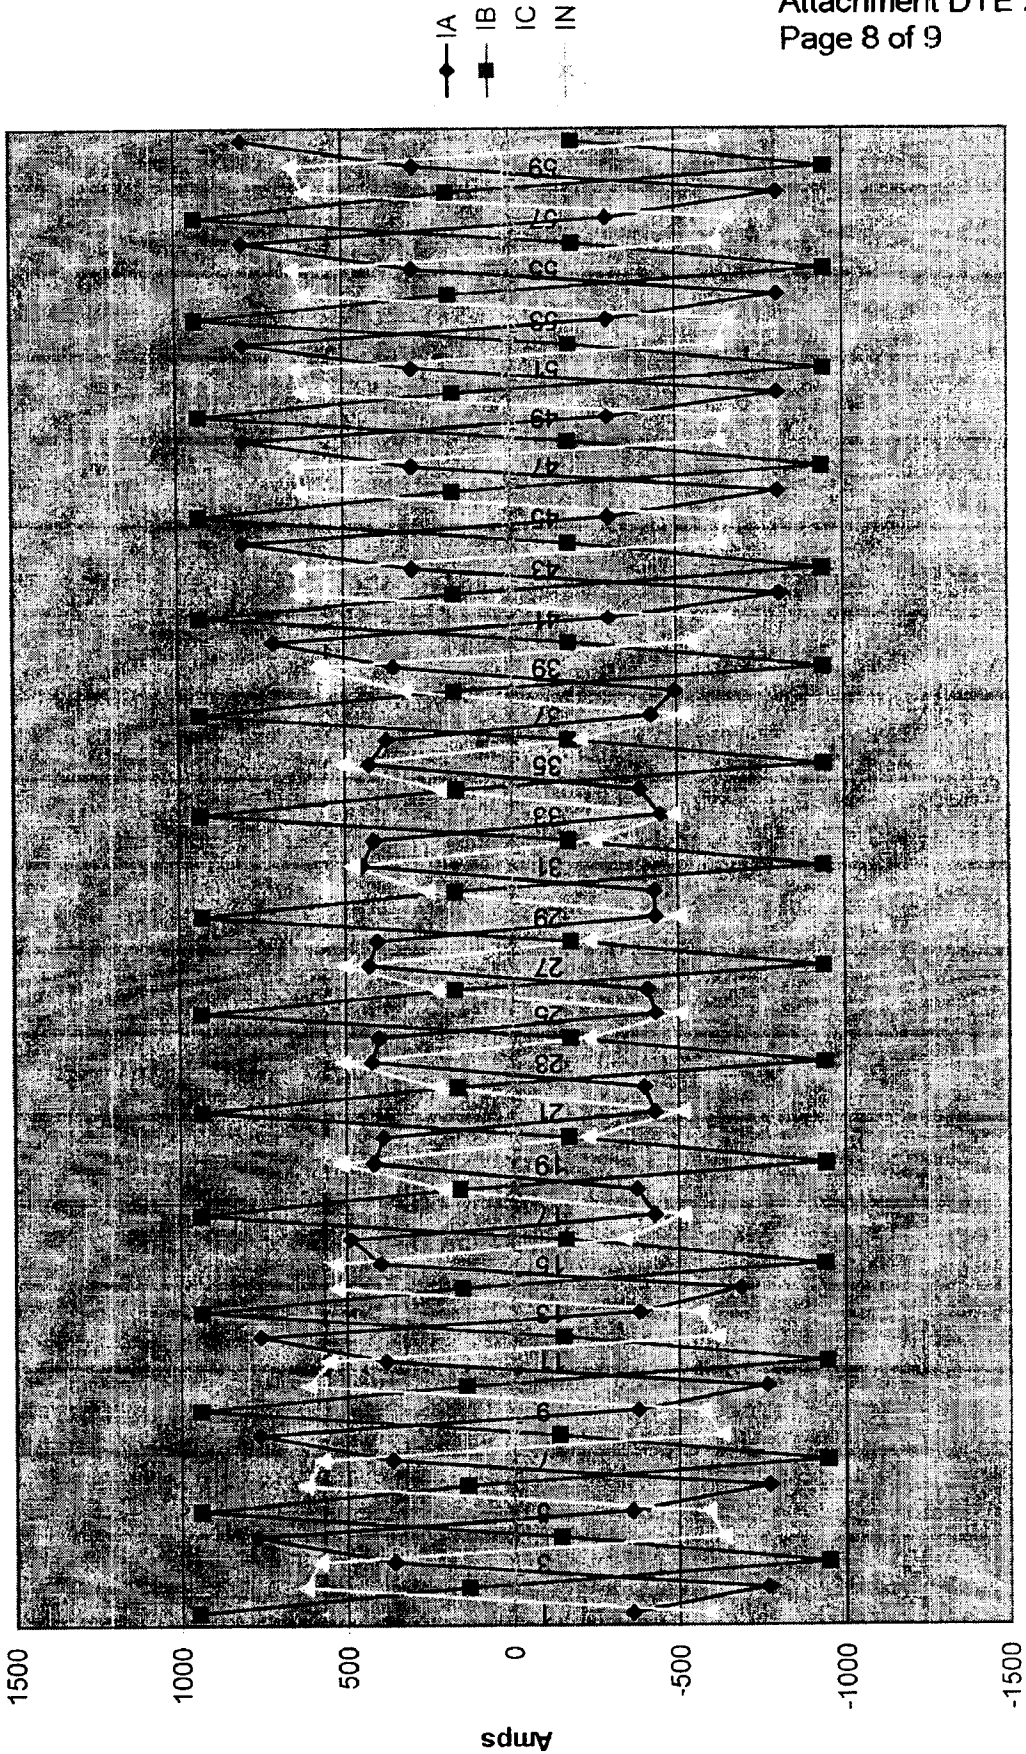
Flagg Pond Currents: June 25, 2001- 05:53:58.943

The fault at this time was permanent. Therefore the Flagg Pond breaker closed back into the fault. Twenty-six seconds after the Flagg Pond breakers reclosed, the River St. transformer experienced a failure in the high side winding, causing the fault current to increase significantly. 0.2 seconds after the high side winding failed, breaker 7B1 at Flagg Pond tripped again and locked-out.
